# Stormwater Pollution Prevention Plan

New York State DEC  
SPDES General Permit  
Ossining Energy  
Storage Project  
4MW/16MWH STC  
Rated Energy Storage  
System

381 N. Highland Avenue  
Ossining, New York 10562

PV Engineers, P.C.  
c/o Borrego Solar Systems, Inc.  
30 Century Hill Dr, Suite 301  
Latham, NY 12110  
Dated: January 4<sup>th</sup>, 2021

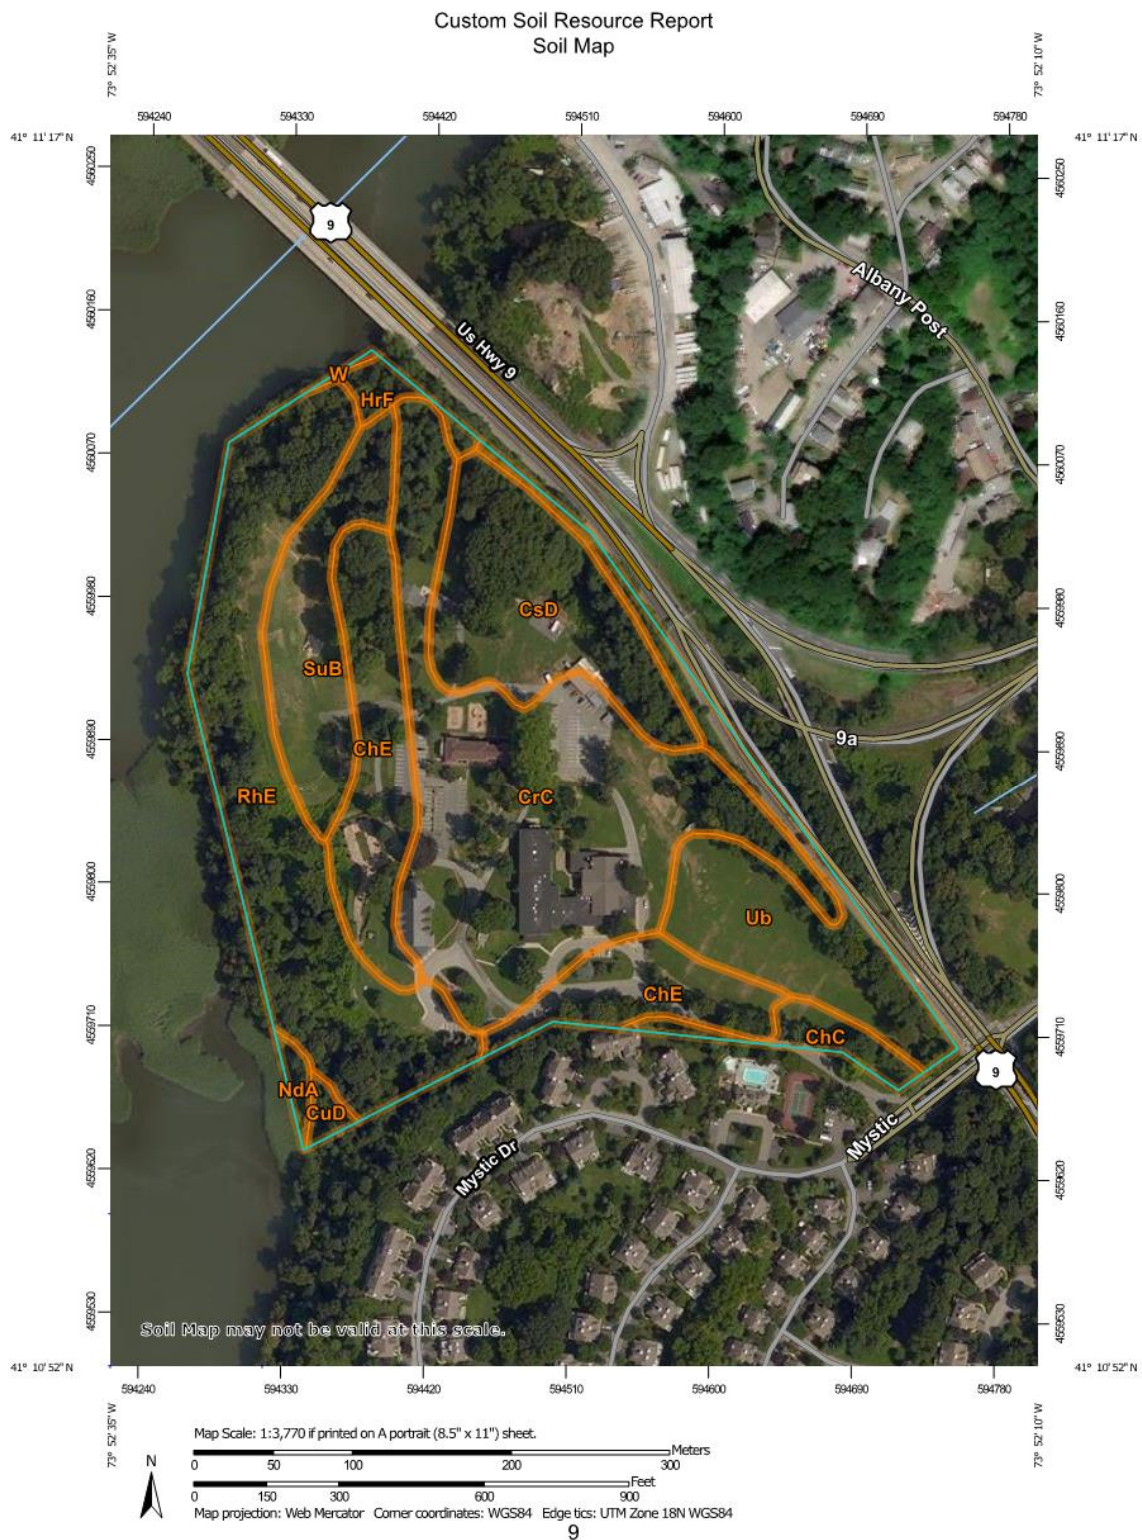
### Figure 3 – Soil Survey

Source: Web Soils  
Survey - NRCS

Runoff rates based on post-construction site conditions have been calculated for a 1-year, 10-year and 100-year storm event, and are shown below. The site contains primarily Hydrological Soil Group B & D soils. The post-construction site conditions will yield very little change in impervious surfaces resulting from the construction of the battery storage areas. The project site has already been developed and it includes the St. Augustine School and Catholic Roman Church, as well as various parking lots and a network of driveways and catch basins. A few other structures and a basketball court are located on the northern part of the site. The remaining available land is a mixture of trees and meadow/brush. The batteries will charge/ discharge via two (2) transformers and (2) power conversion systems located within the fenced area, each having an approximate area of 214 ft<sup>2</sup>. The power conversion system and associated equipment will be located on a concrete pad and connected to the existing utility grid via underground conduit from the interconnection equipment at the front of the site, adjacent to US 9/NY 9A/N Highland Avenue. The underground conduit will be installed adjacent to the access road for approximately 740 LF to reach the interconnection equipment. The interconnection equipment consists of a pad mounted disconnect box, a pad mounted high tension metering enclosure (both having an area of about 55 ft<sup>2</sup>), and two (2) utility poles carrying vertically mounted interconnection equipment.

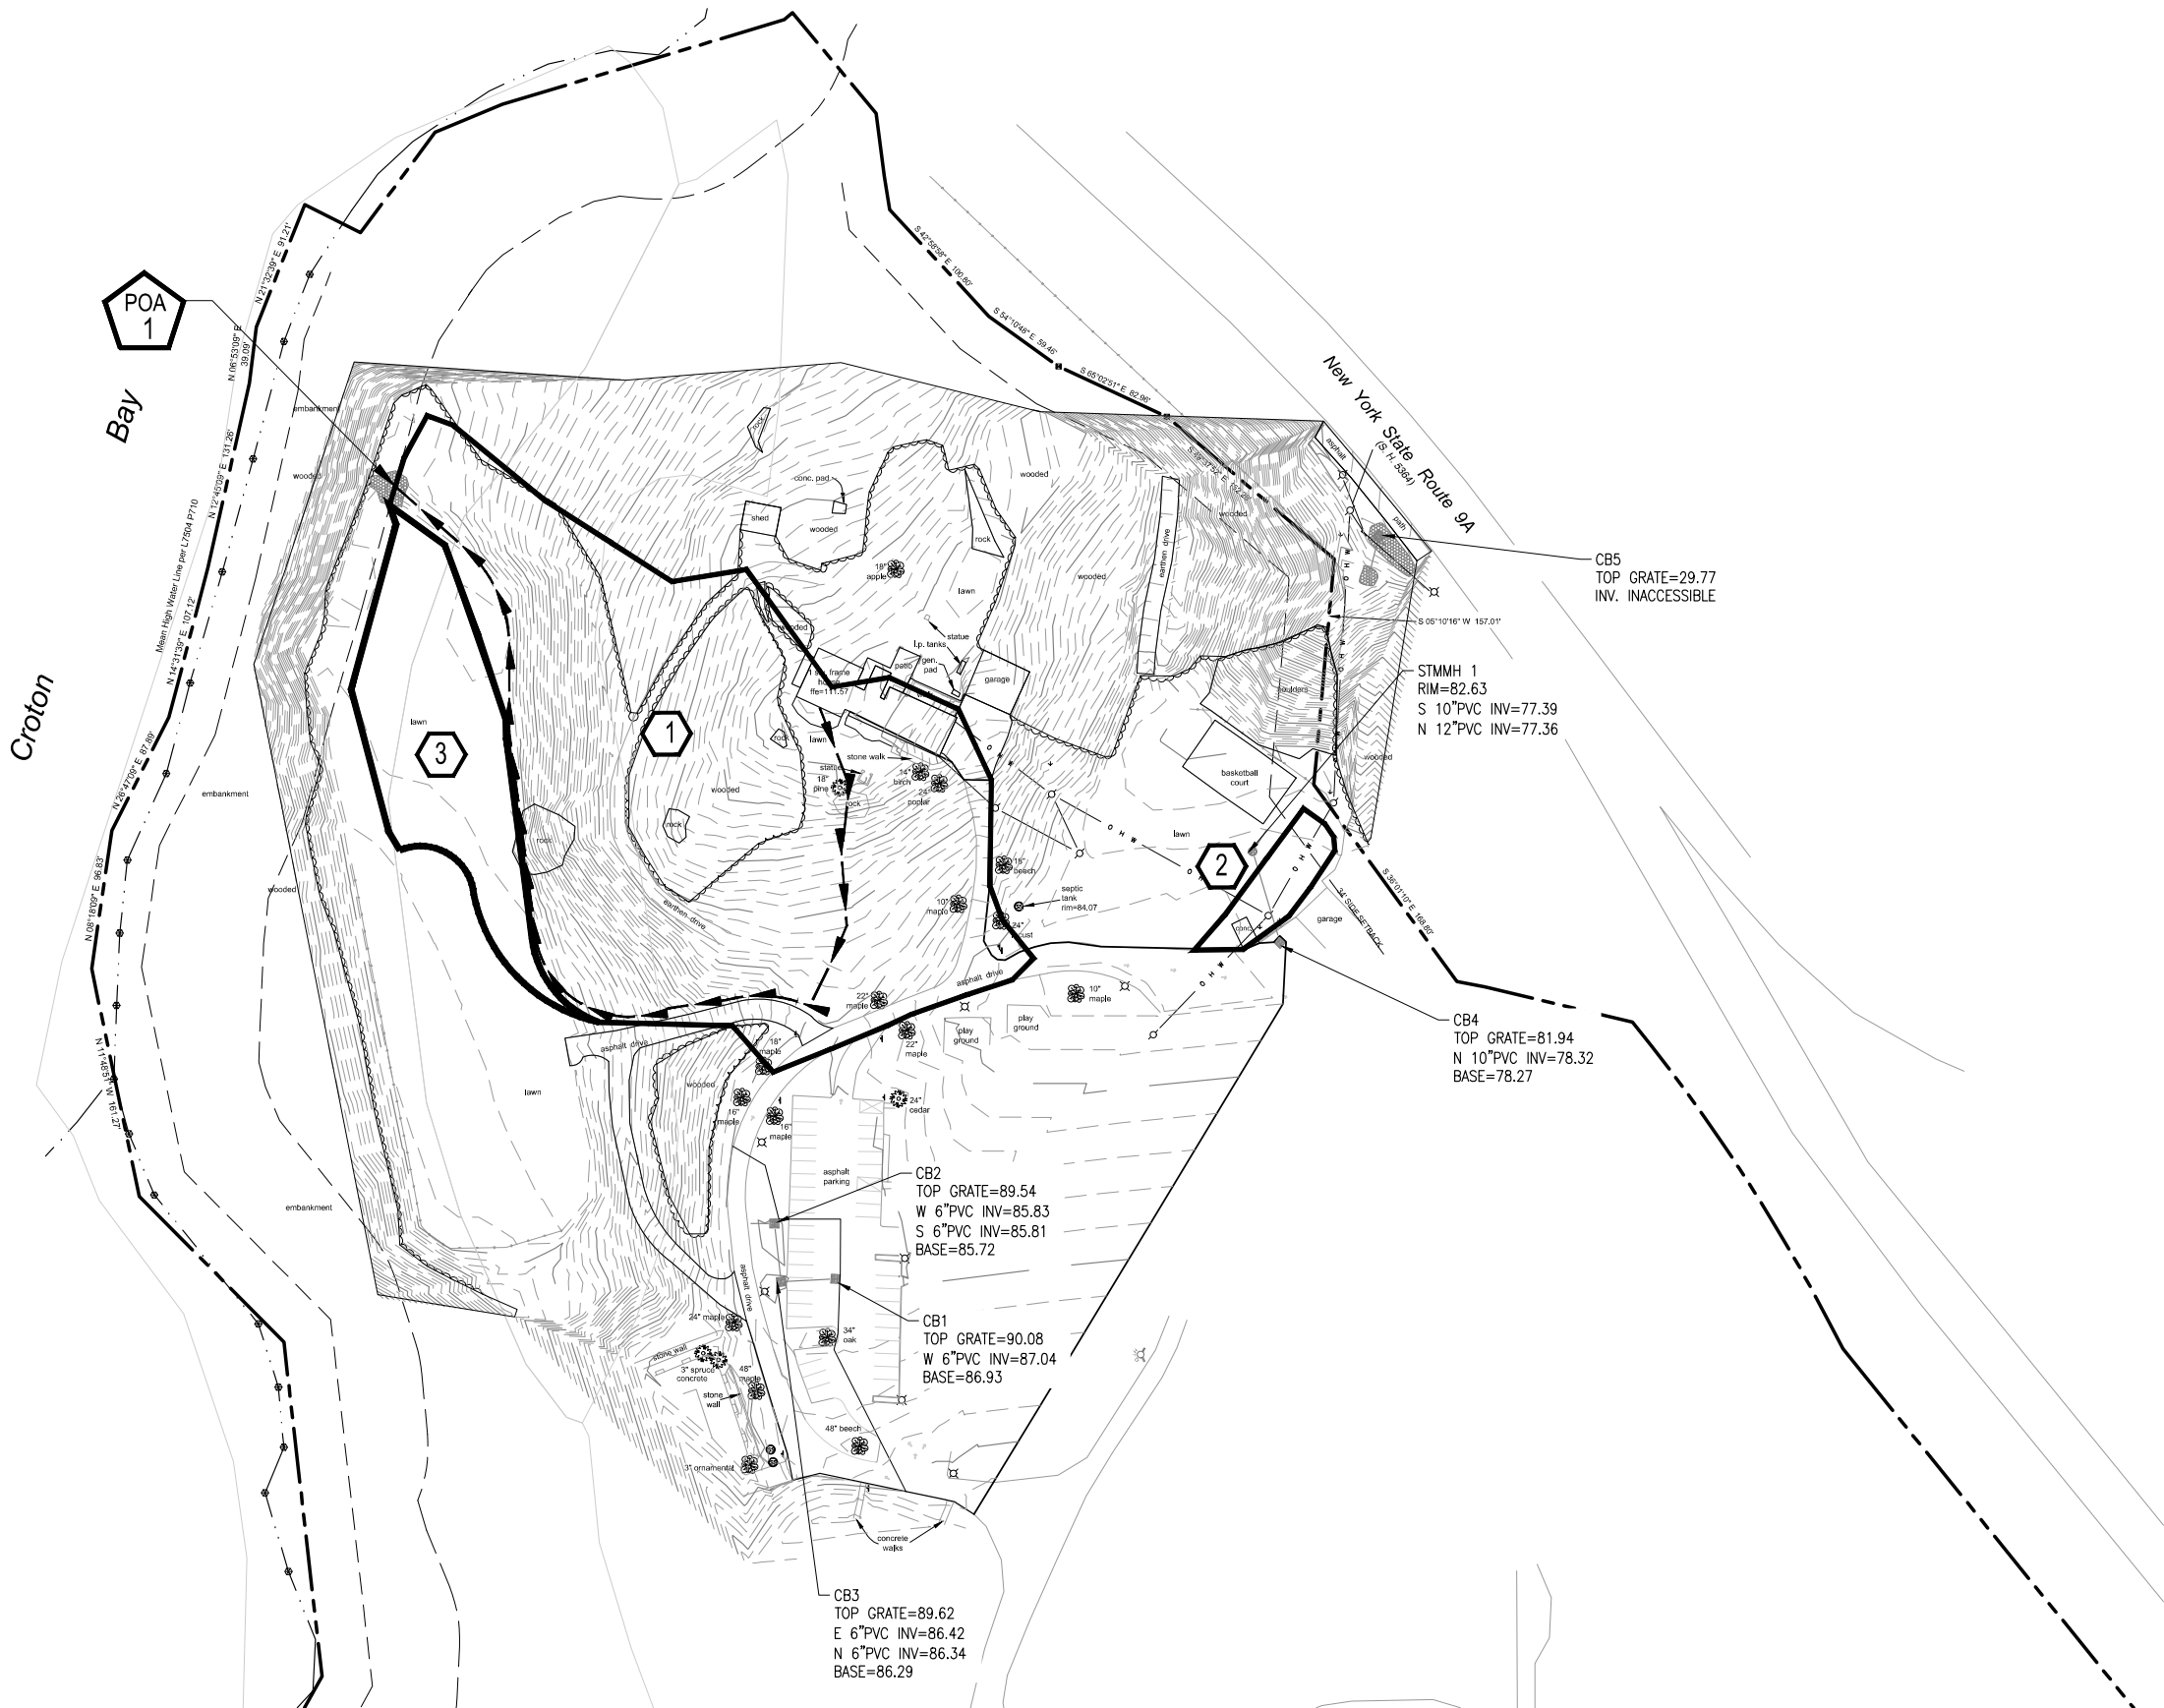
**W-1.0**  
PRE-DEVELOPMENT PLAN

## PRE-DEVELOPMENT PLAN

The drainage areas and flow patterns for existing and post-development conditions are similar except for an increase in impervious areas associated with the development. The existing drainage patterns for the site are established within the project limits and are shown in Appendix F. There are tributary areas that flow through the site, which will be allowed to maintain their drainage patterns and are included in these calculations. The existing combined peak discharge from the site for the 1-year, 10-year and 100-year storm event is presented in the attached reports and hydrographs.

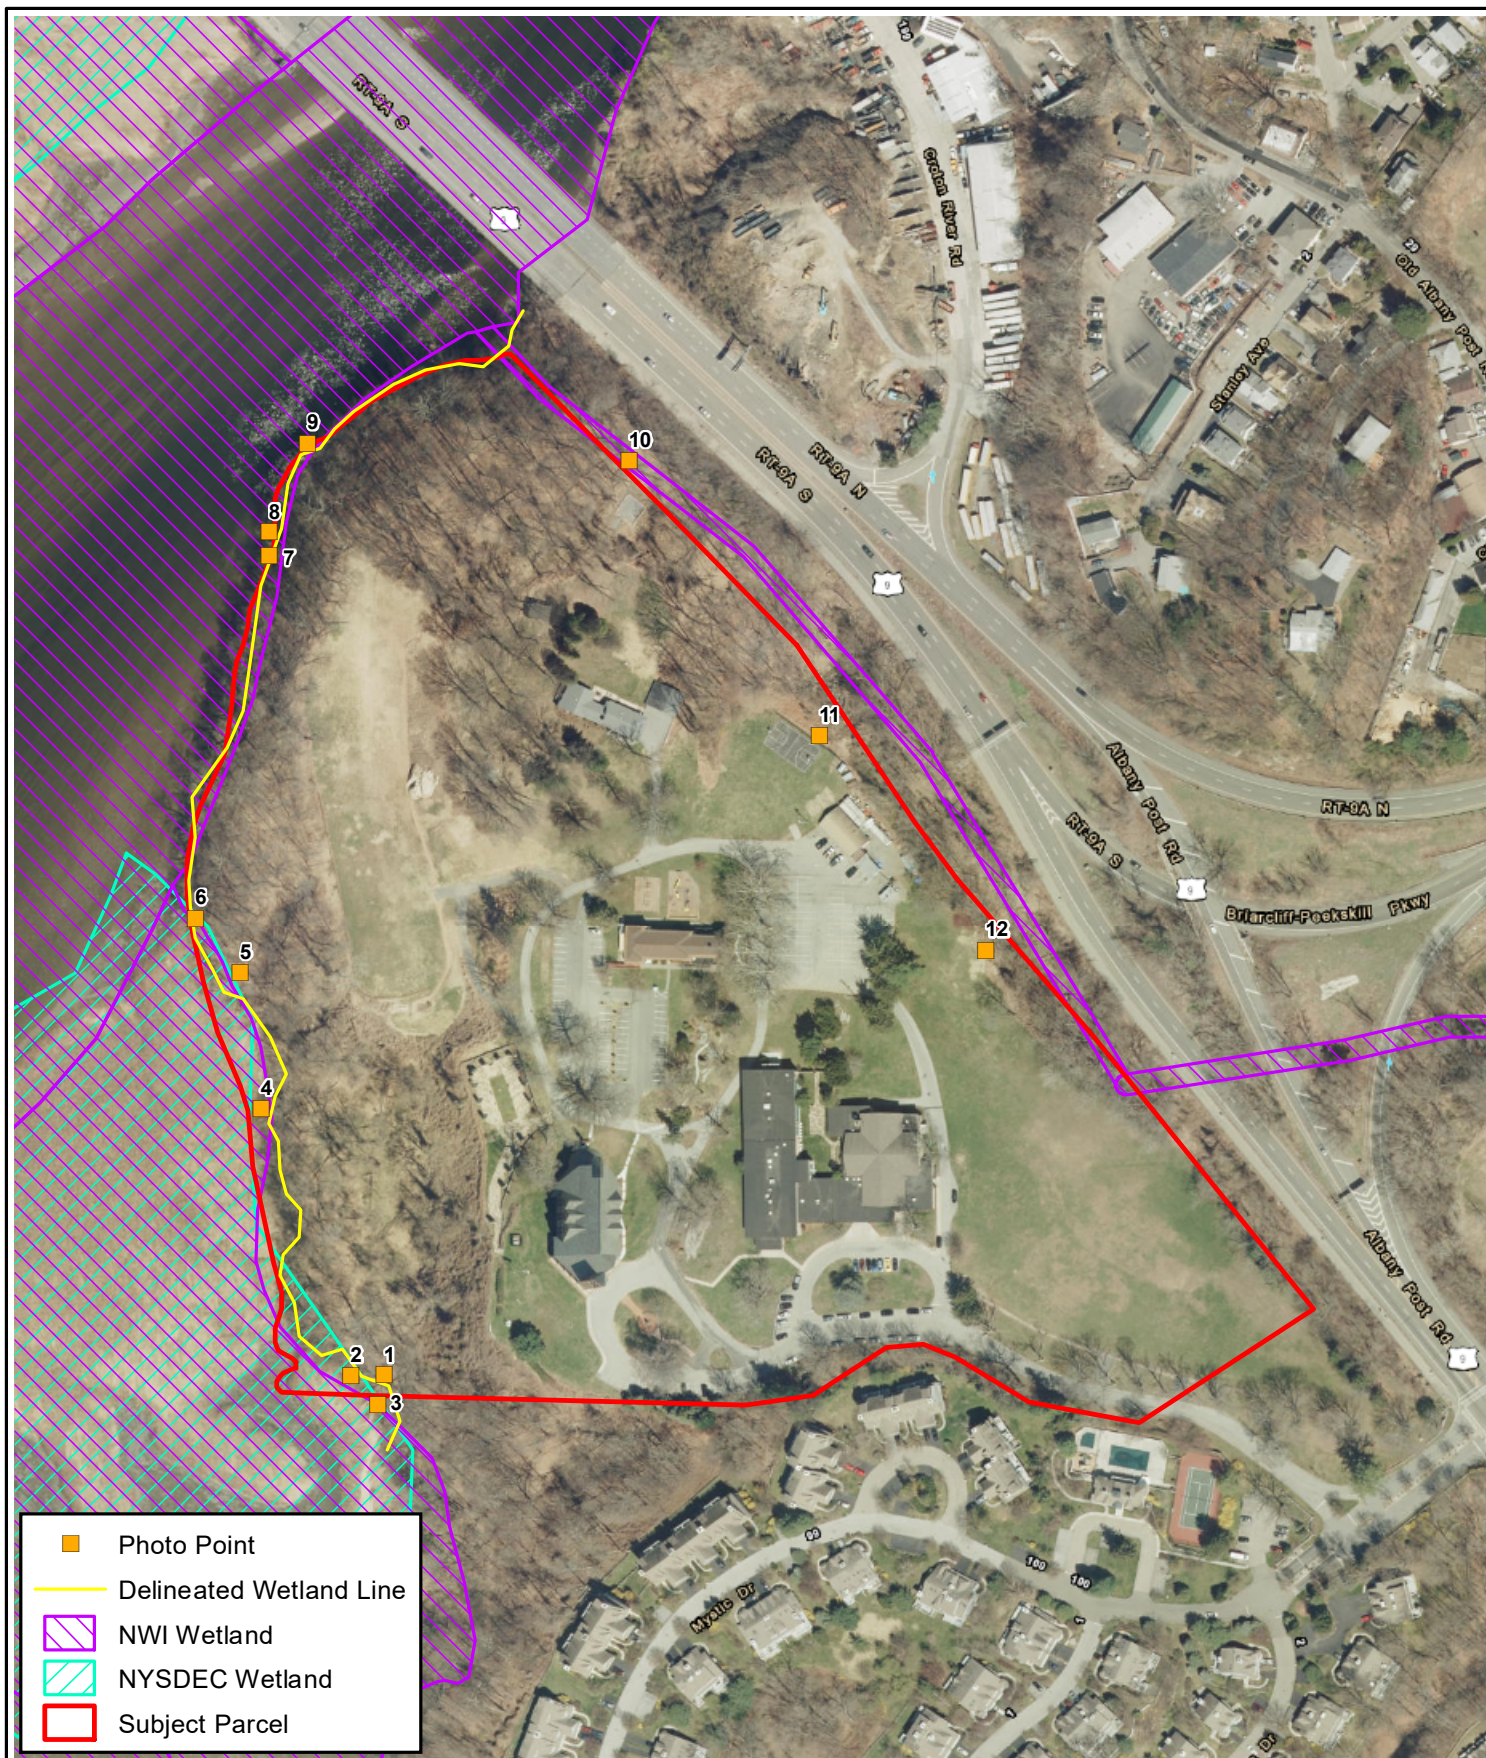
| | Photo Point |
| | Delineated Wetland Line |
