Landscape Design, Rear Parking Lot  
512Bistro Bar Restaurant  
512 North State Road  
Briarcliff Manor, Town of Ossining, NY

Stephen Lopez, AICP, RLA  
June 22, 2026

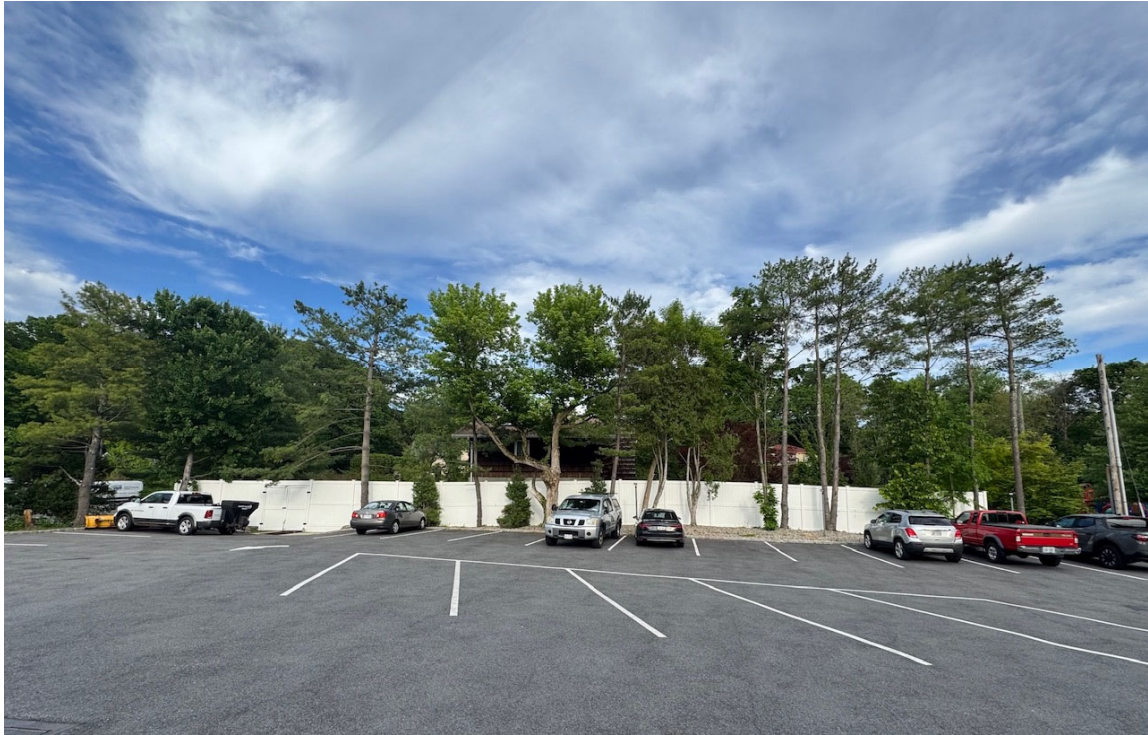
Existing Conditions  
512Bistro Bar Restaurant, North State Road, Wide Angle Photo May 26, 2026

Recent modifications were made to the rear of the 512Bistro Bar Restaurant parking lot, the exact date is unclear. They included removal of some vegetation, trimming some remaining vegetation (trees), and realigning the curb. The above photo, taken on a site visit on May 26, 2026, illustrates the existing tree condition. The remaining trees are providing no substantive screening to the second story of the neighboring house. A new eight foot high solid panel fence and three approximately 10-12 foot high White Pines have been installed inside the planting bed. The applicant has been directed by the Town to address the condition with consideration of additional new plantings to screen the neighboring residence and provide aesthetic improvement to the perimeter of the rear parking area.

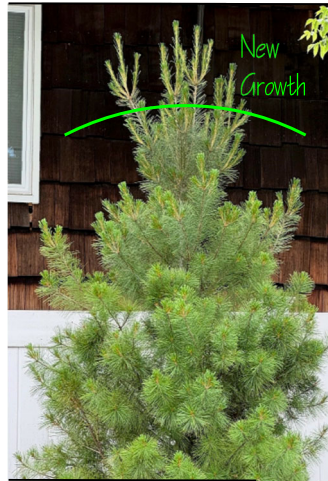
The three new White Pines planted one year ago have settled into the site well. They have put out new growth (candles) in this growing season of approximately 6 to 10 inches so far, and can be expected to continue growth to 10 to 12 inches or more. They currently reach between the bottom of the window frame to more than halfway up the window, depending on where the view point is. The photo below was taken on June 17, 2025, approximately 30 feet from the fence.

Recently planted White Pine

Additional screening is proposed for the second story of the adjacent house. This would be achieved by planting 2 infill White Pines between the three recently planted White Pines. The infill White Pines would be the same size as the recently planted White Pines. This would create a line of 5 trees that would take approximately 2-3 years to reach the top of the neighbor's second story house window and beyond (again, depending on the viewpoint), and an additional 2-3 years to fill in and fully cover the window and view of most of the parking lot.

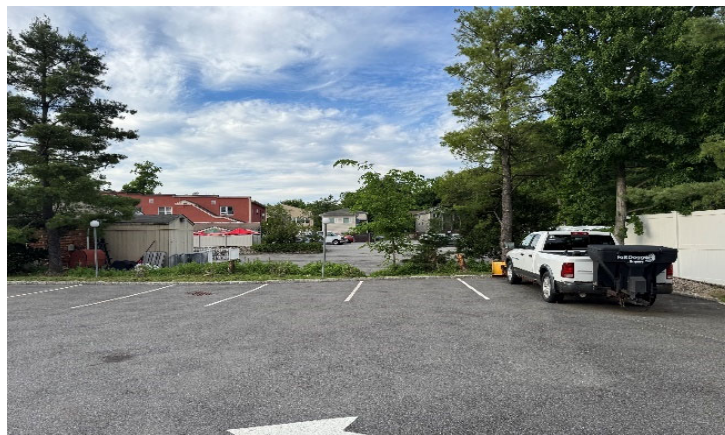
At the left side of the rear parking area is an open view of the neighboring commercial site. This view includes various materials stored along the side of the building, and of the neighboring parking lot.

View of neighboring commercial property

The left side of the parking lot adjacent to the neighboring commercial property would be screened with plantings for the benefit of restaurant patrons with a view of this area. These plants would include 3 Giant Arborvitae flanked on each side by Star Magnolias. These deciduous trees reach 20 – 25 feet high at maturity and flower white in early spring.

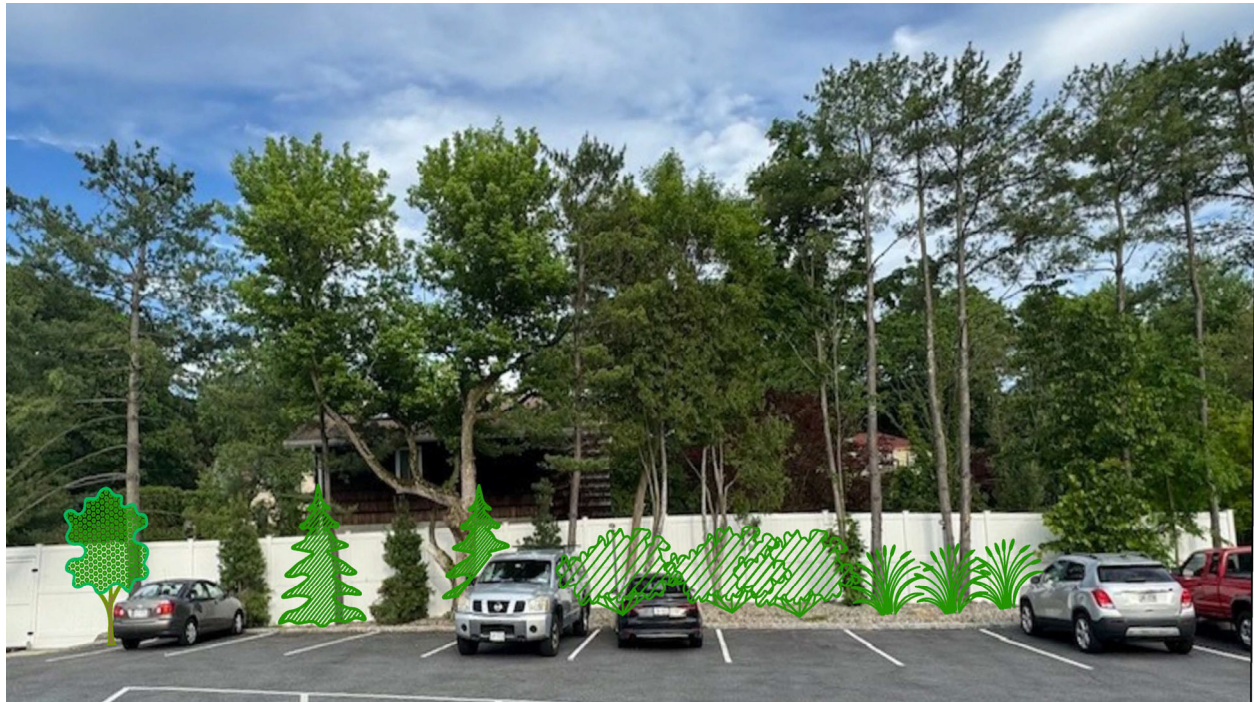
On the right side of the White Pines are proposed two groupings of large shrubs. The Leather Leaf Viburnum is an evergreen shrub that flowers in late spring and can reach heights of 12 - 15 feet or more in height and width. The Bridal Wreath is a deciduous white flowering shrub that flowers in mid spring and can reach 5 – 6 feet or more. To the far right and far left of these new plantings Kousa Dogwood trees are proposed. These deciduous trees flower in late spring into early summer and grow 20 - 25 feet in height.

At the parking lot entrance off Blue Lantern Road two columnar Red Oak are proposed in the island connected to the rear planting area. These would provide an entrance statement without overgrowing the parking area.

View of rear parking lot at 512Bistro with screening

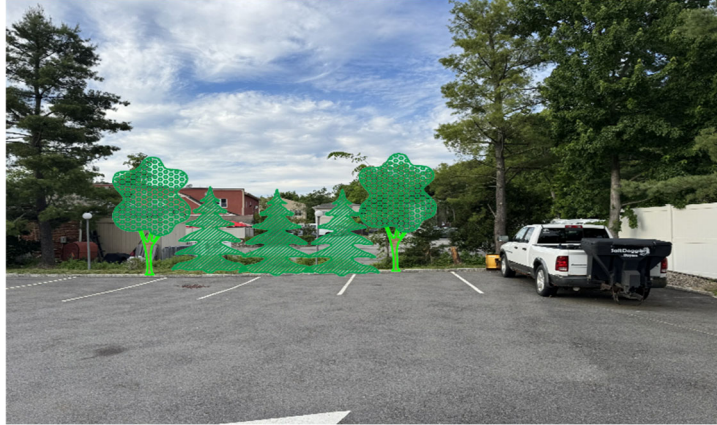
View of neighboring commercial property with screening
